The Road Inventory of Bear Lake National Wildlife Refuge Montpelier, ID

Prepared By:
Federal Highway Administration
Central Federal Lands Highway Division
May 2013

Bear Lake NWR - 14613 Summaries

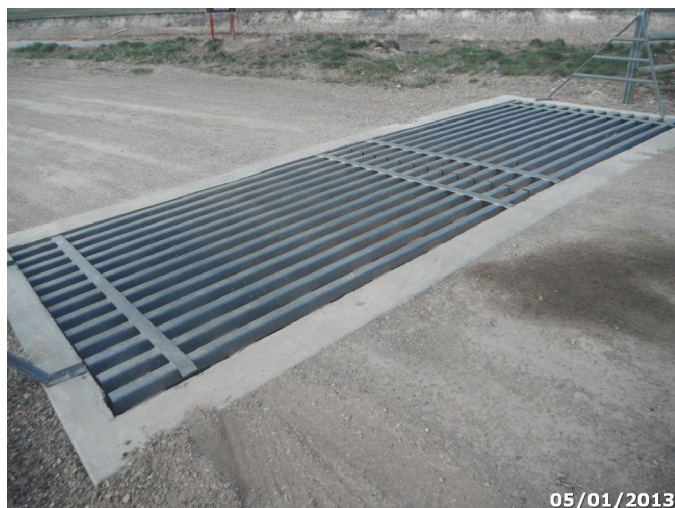
Photo: BELA_C4_0692 Route: 010-001-0.01
Metal Cattle Guard

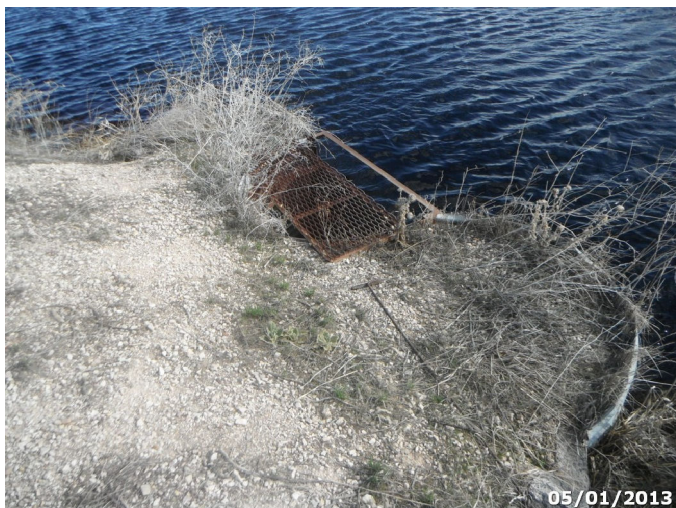
Photo: BELA_C4_0693 Route: 010-001-0.29
Metal WCS Flashboard Riser 50ft long 48in dia. 4ft deep

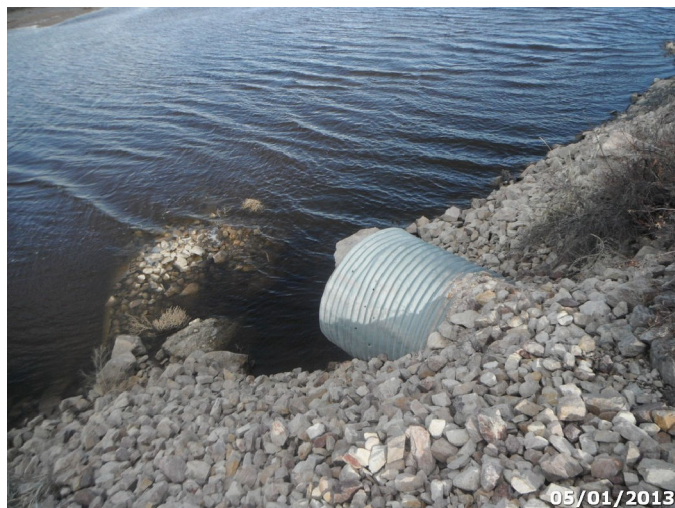
Photo: BELA_C4_0694 Route: 010-001-0.29
Metal WCS Flashboard Riser 50ft long 48in dia. 4ft deep

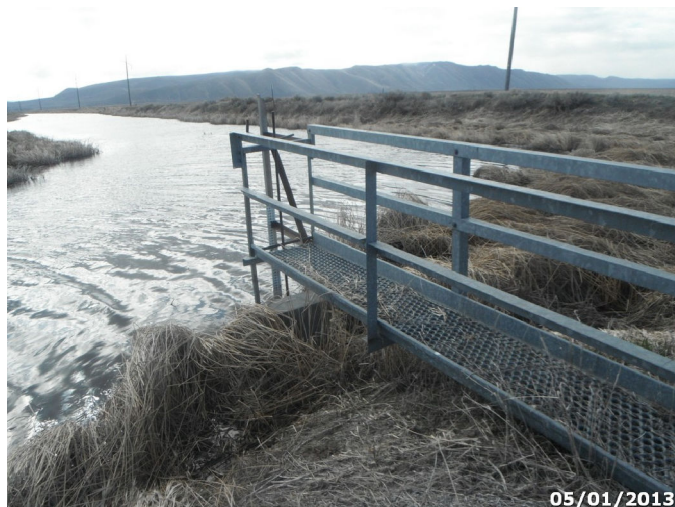
Photo: BELA_C4_0696 Route: 010-002-2.1
Metal WCS Flashboard Riser 50ft long 36in dia. 4ft deep
8-001

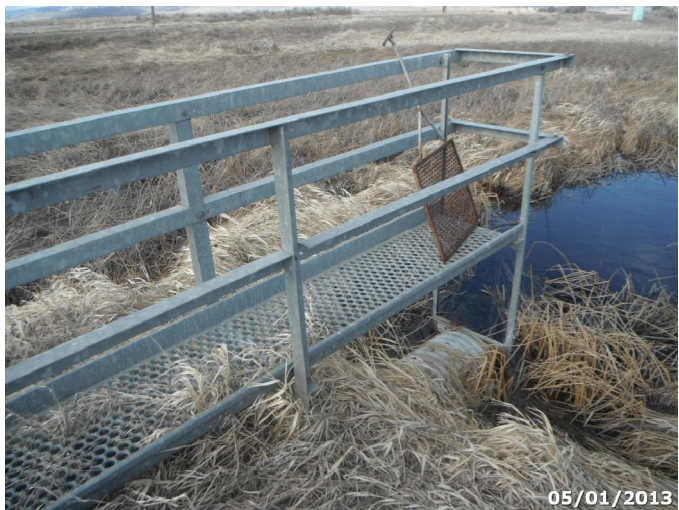
Photo: BELA_C4_0697 Route: 010-002-2.1

Metal WCS Flashboard Riser 50ft long 36in dia. 4ft deep

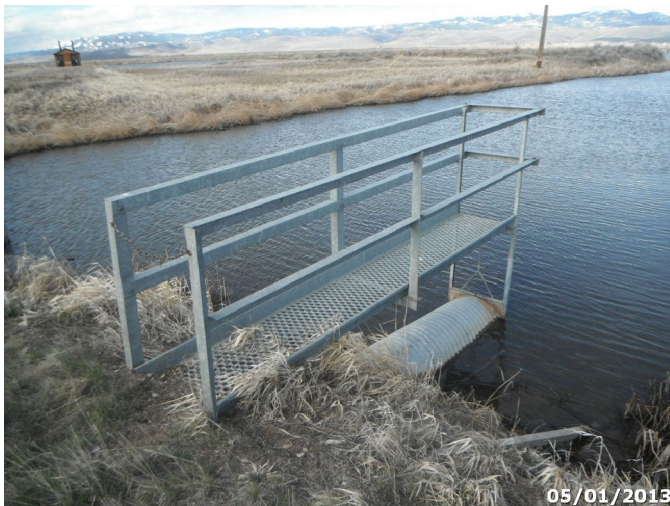
Photo: BELA_C4_0701 Route: 011-001-0.01
Metal WCS Screw Gate 50ft long 36in dia. 4ft deep

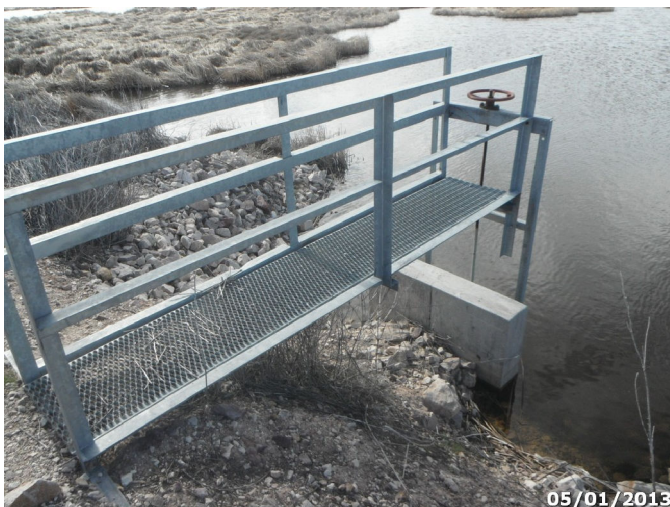
Photo: BELA_C4_0704 Route: 011-001-0.79
Metal WCS Screw Gate 40ft long 48in dia. 4ft deep

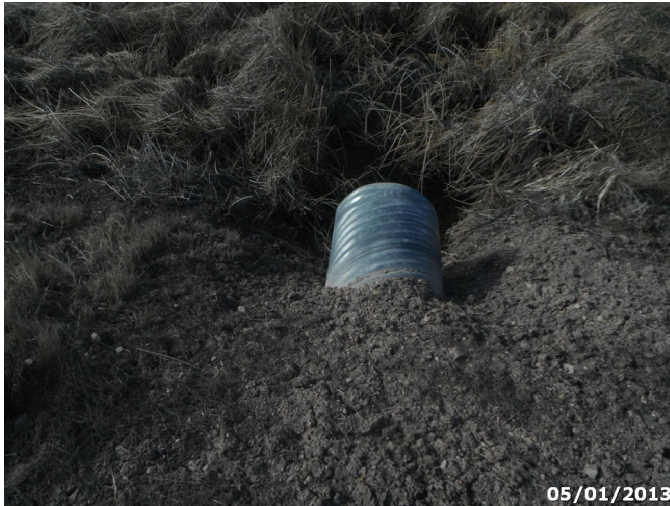
Photo: BELA_C4_0707 Route: 011-002-1.75
Metal Culvert 40ft long 36in dia. 4ft deep

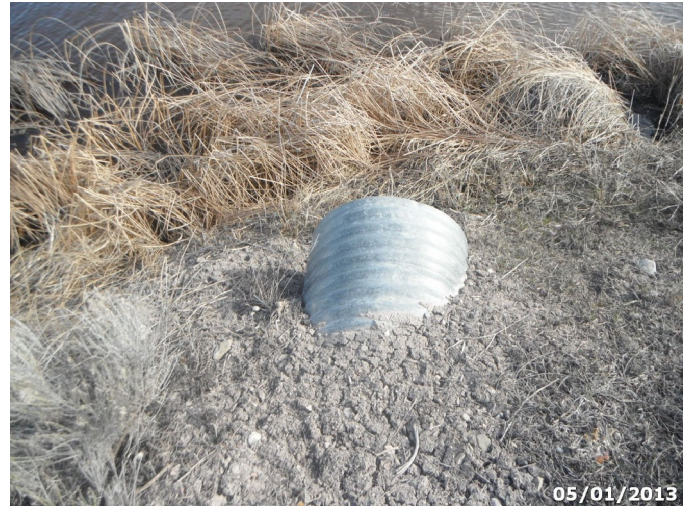
Photo: BELA_C4_0708 Route: 011-002-1.75
Metal Culvert 40ft long 36in dia. 4ft deep

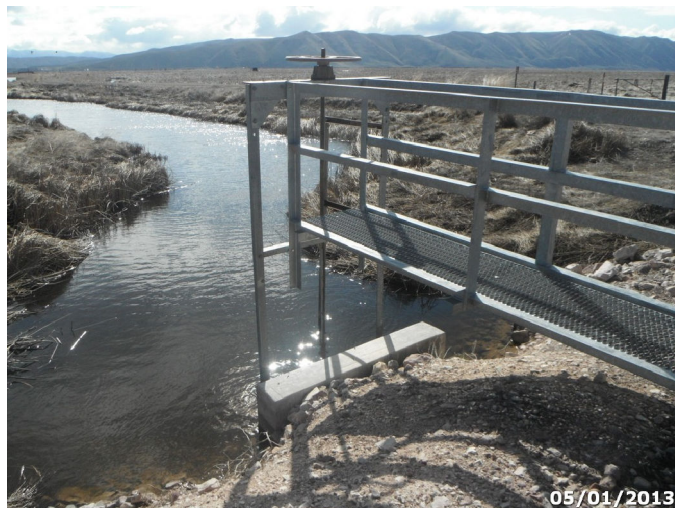
Photo: BELA_C4_0714 Route: 100-001-0.87
Metal WCS Screw Gate 50ft long 60in dia. 3ft deep

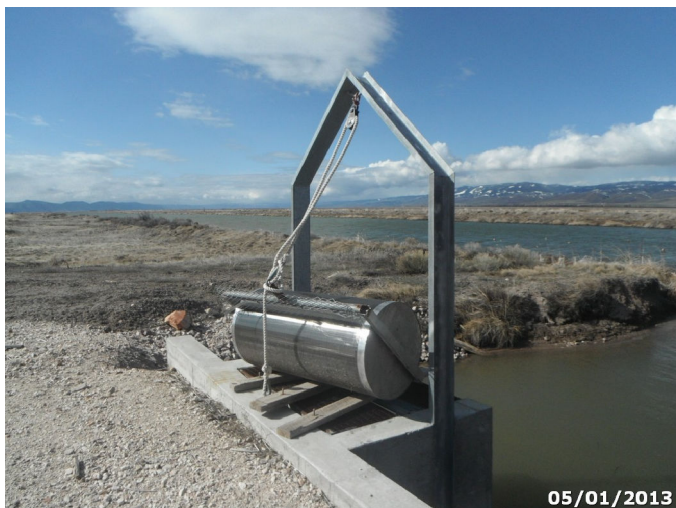
Photo: BELA_C4_0715 Route: 100-001-0.87
Metal WCS Screw Gate 50ft long 60in dia. 3ft deep

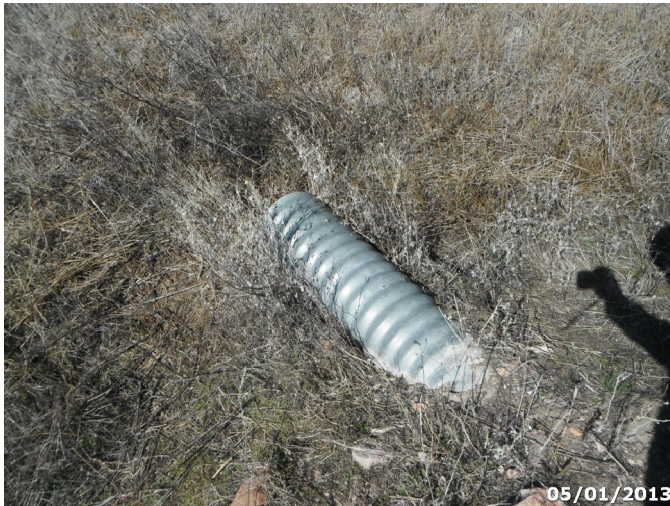
Photo: BELA_C4_0740 Route: 101-001-0.01
Metal Culvert 20ft long 12in dia. 1ft deep

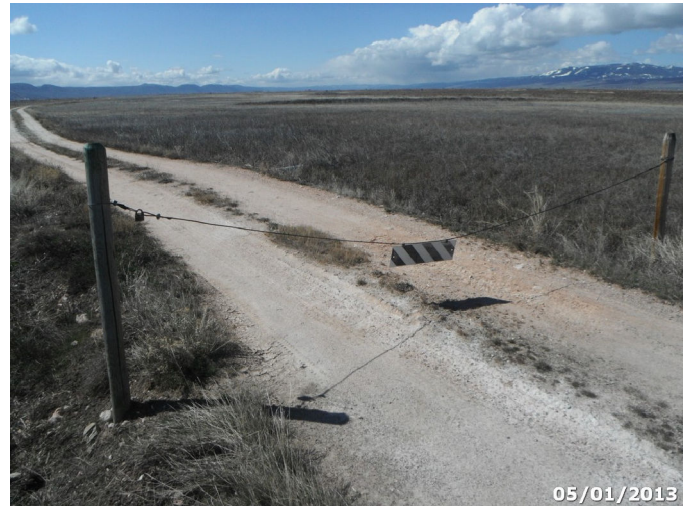
Photo: BELA_C4_0738 Route: 101-001-0.01
Metal Cable Gate

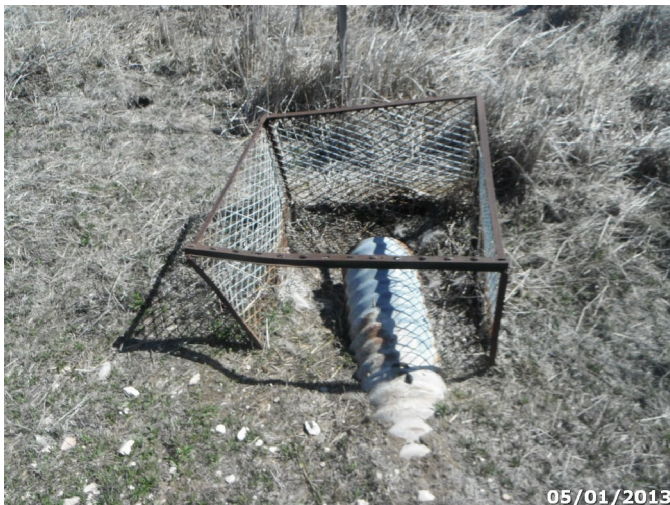
Photo: BELA_C4_0741 Route: 101-001-0.18
Metal Culvert 20ft long 12in dia. 1ft deep

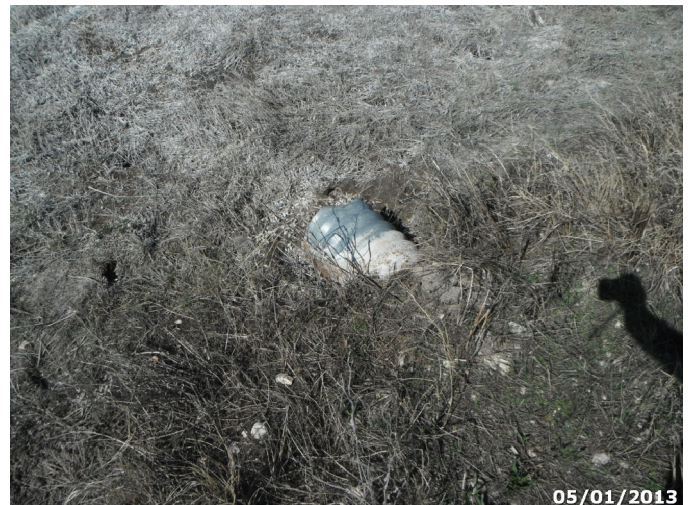
Photo: BELA_C4_0742 Route: 101-001-0.18
Metal Culvert 20ft long 12in dia. 1ft deep

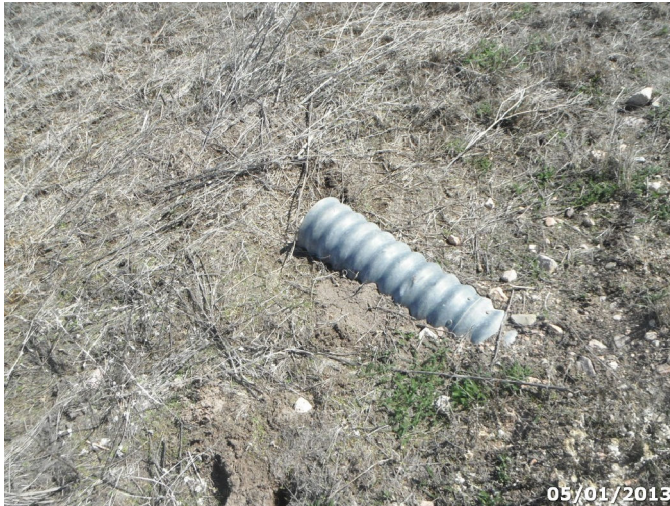
Photo: BELA_C4_0743 Route: 101-001-0.24
Metal Culvert 20ft long 6in dia. 1ft deep

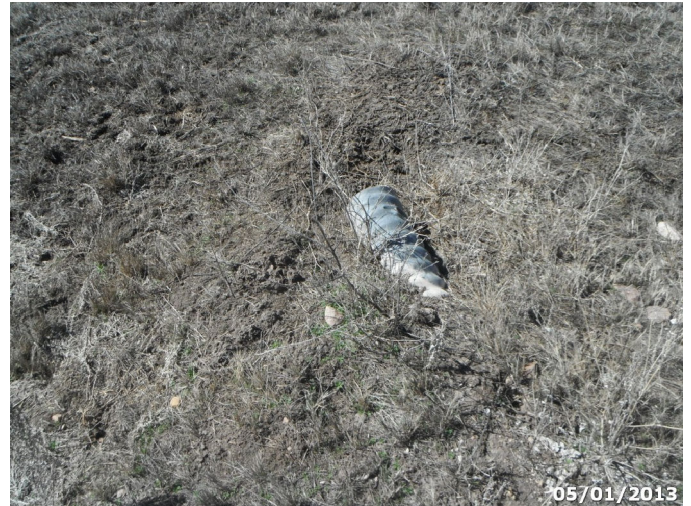
Photo: BELA_C4_0744 Route: 101-001-0.24
Metal Culvert 20ft long 6in dia. 1ft deep
